STS-1 Orbiter Final Mission Report

August 1981

National Aeronautics and
Space Administration

Lyndon B. Johnson Space Center
Houston, Texas

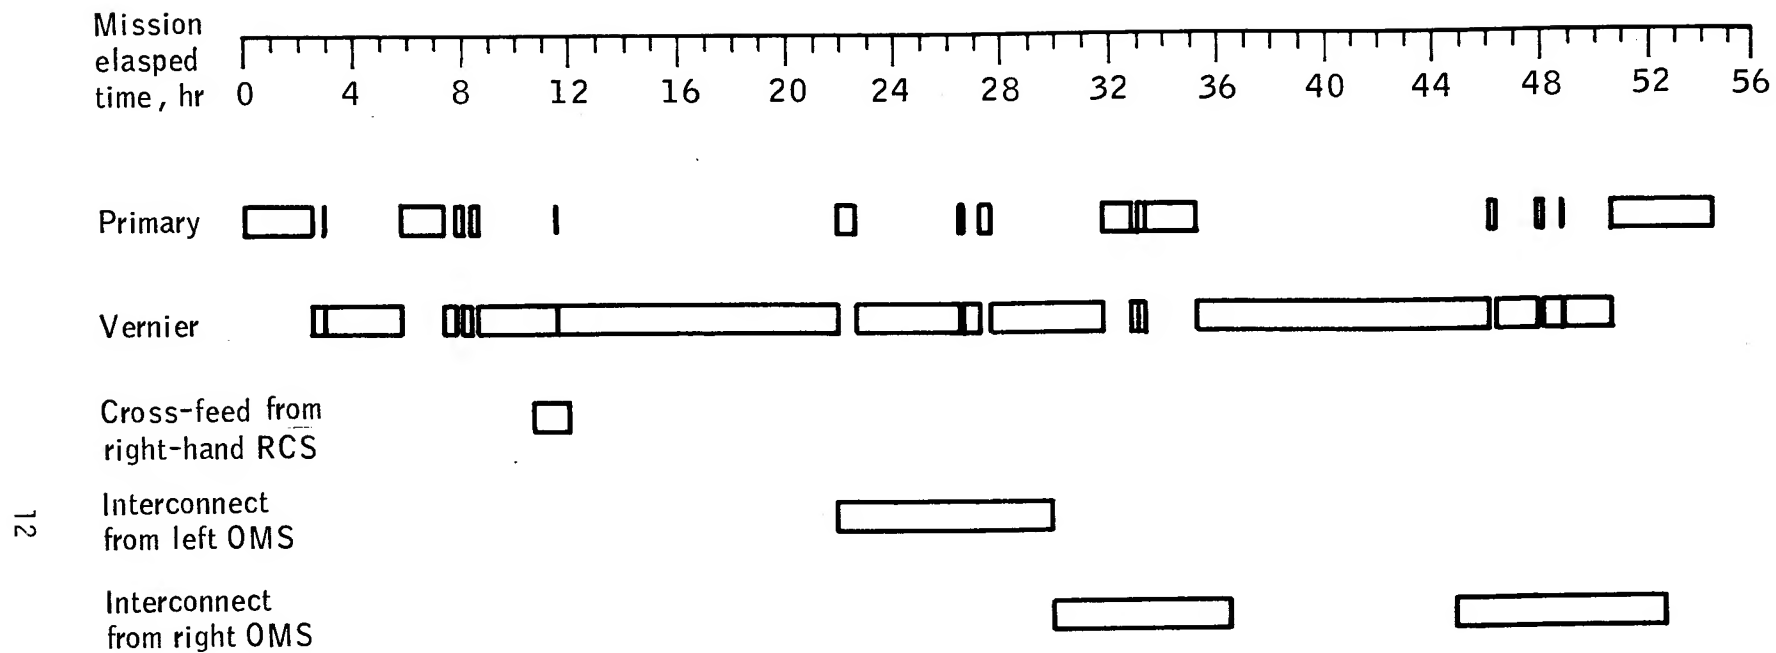
Figure 2-2.- Reaction control system configurations during STS-1.

The OMS-to-RCS interconnect operation deviated from the preplanned procedure. All of the RCS test firings were conducted while interconnected to the left OMS; whereas it was planned that only the first RCS test would use left OMS propellant. The OMS fed propellants to the RCS for approximately 22 hours during the 54-hour mission, and during that period, propellant usage was 709 lbm (5.5 percent) from the left pod and 725 lbm (5.6 percent) from the right pod. Pressurization of the propellant tanks was performed manually when required by a low-pressure condition in the propellant tanks or when the OMS and RCS were returned to the normal configuration. An exception to this occurred when the right OMS was returned to normal configuration just prior to the deorbit maneuver. The right pod propellant tanks were not repressurized; therefore, the deorbit maneuver ignition was performed with the right pod propellant pressures approximately 7 psi below regulated pressure. System operation during the interconnect period was normal, with no anomalous interactions between OMS and RCS.

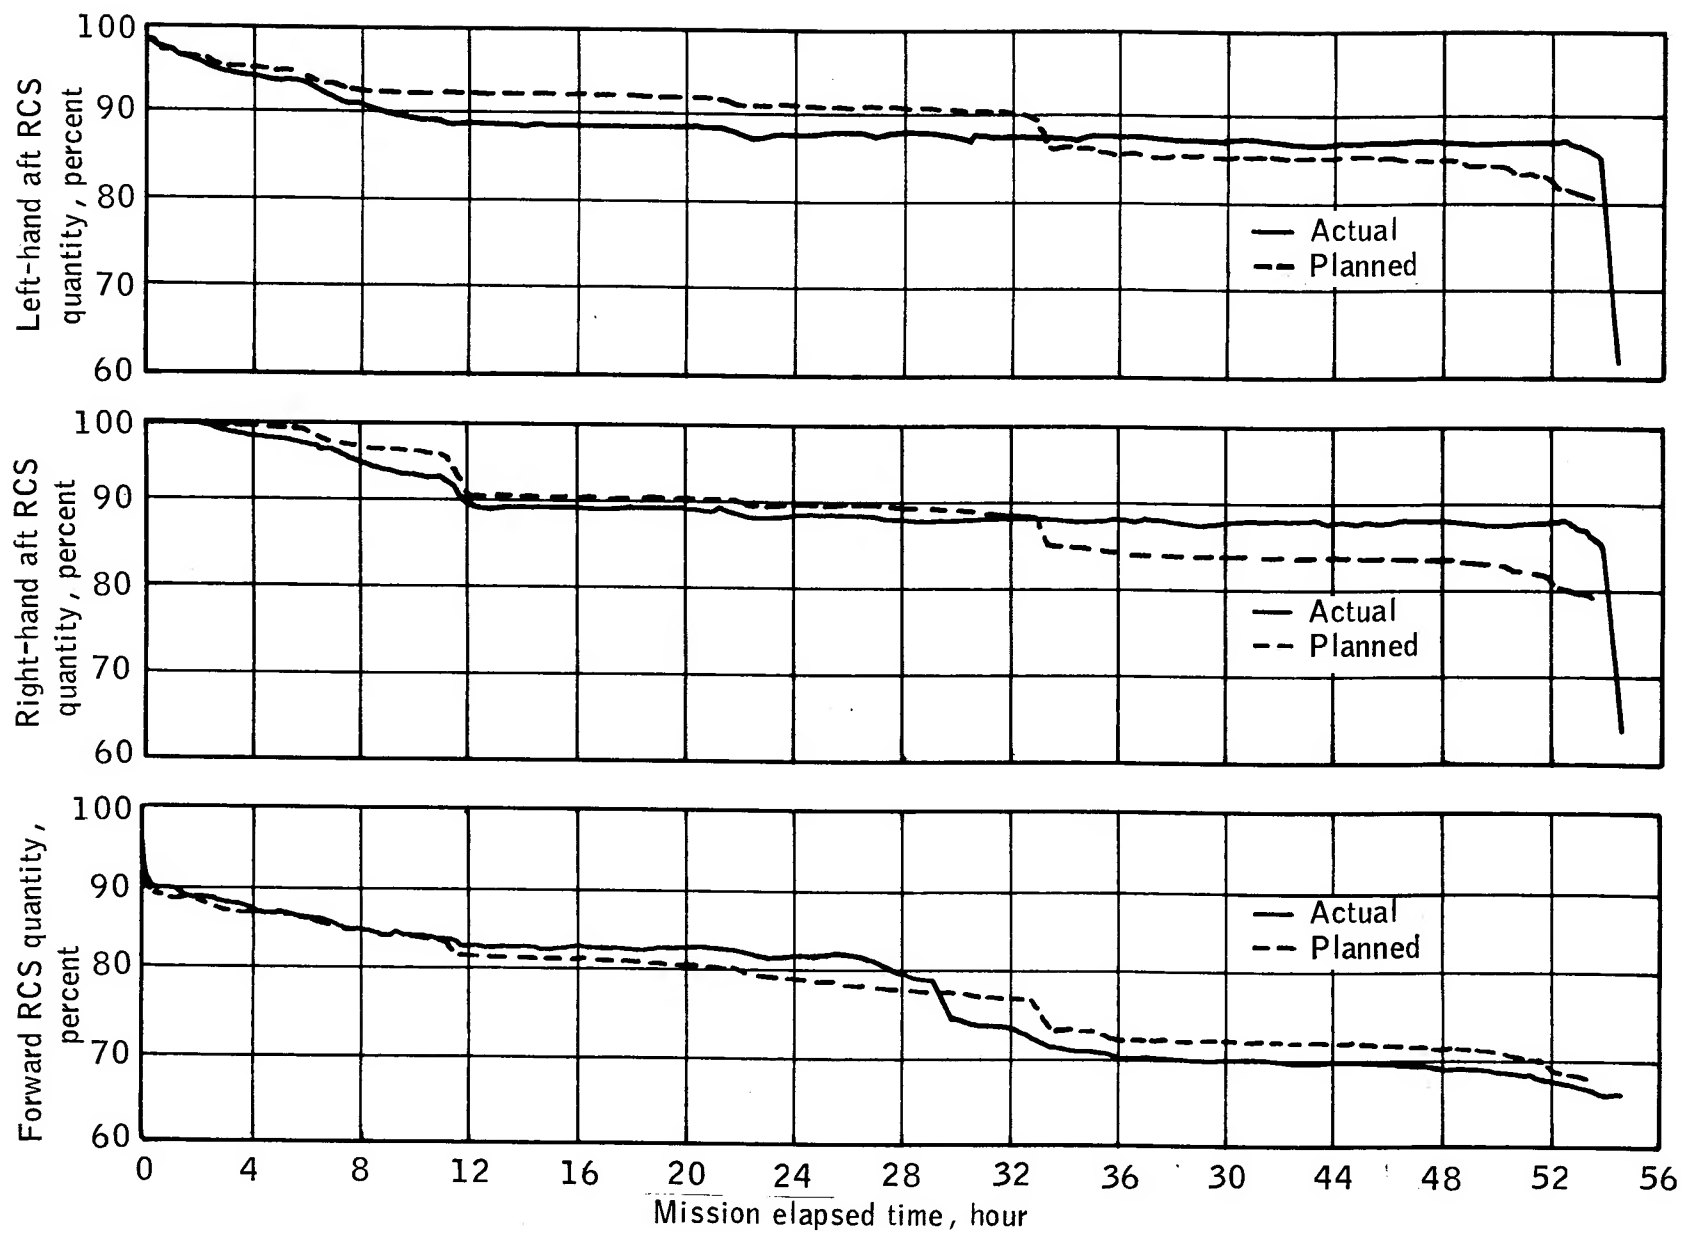
Figure 2-3.- RCS propellant remaining as a function of time during STS-1.

Propellant consumption from the RCS was close to preflight predictions, as illustrated by figure 2-3. A tabulation of propellant used from the RCS as a function of mission phase is shown in the following table.

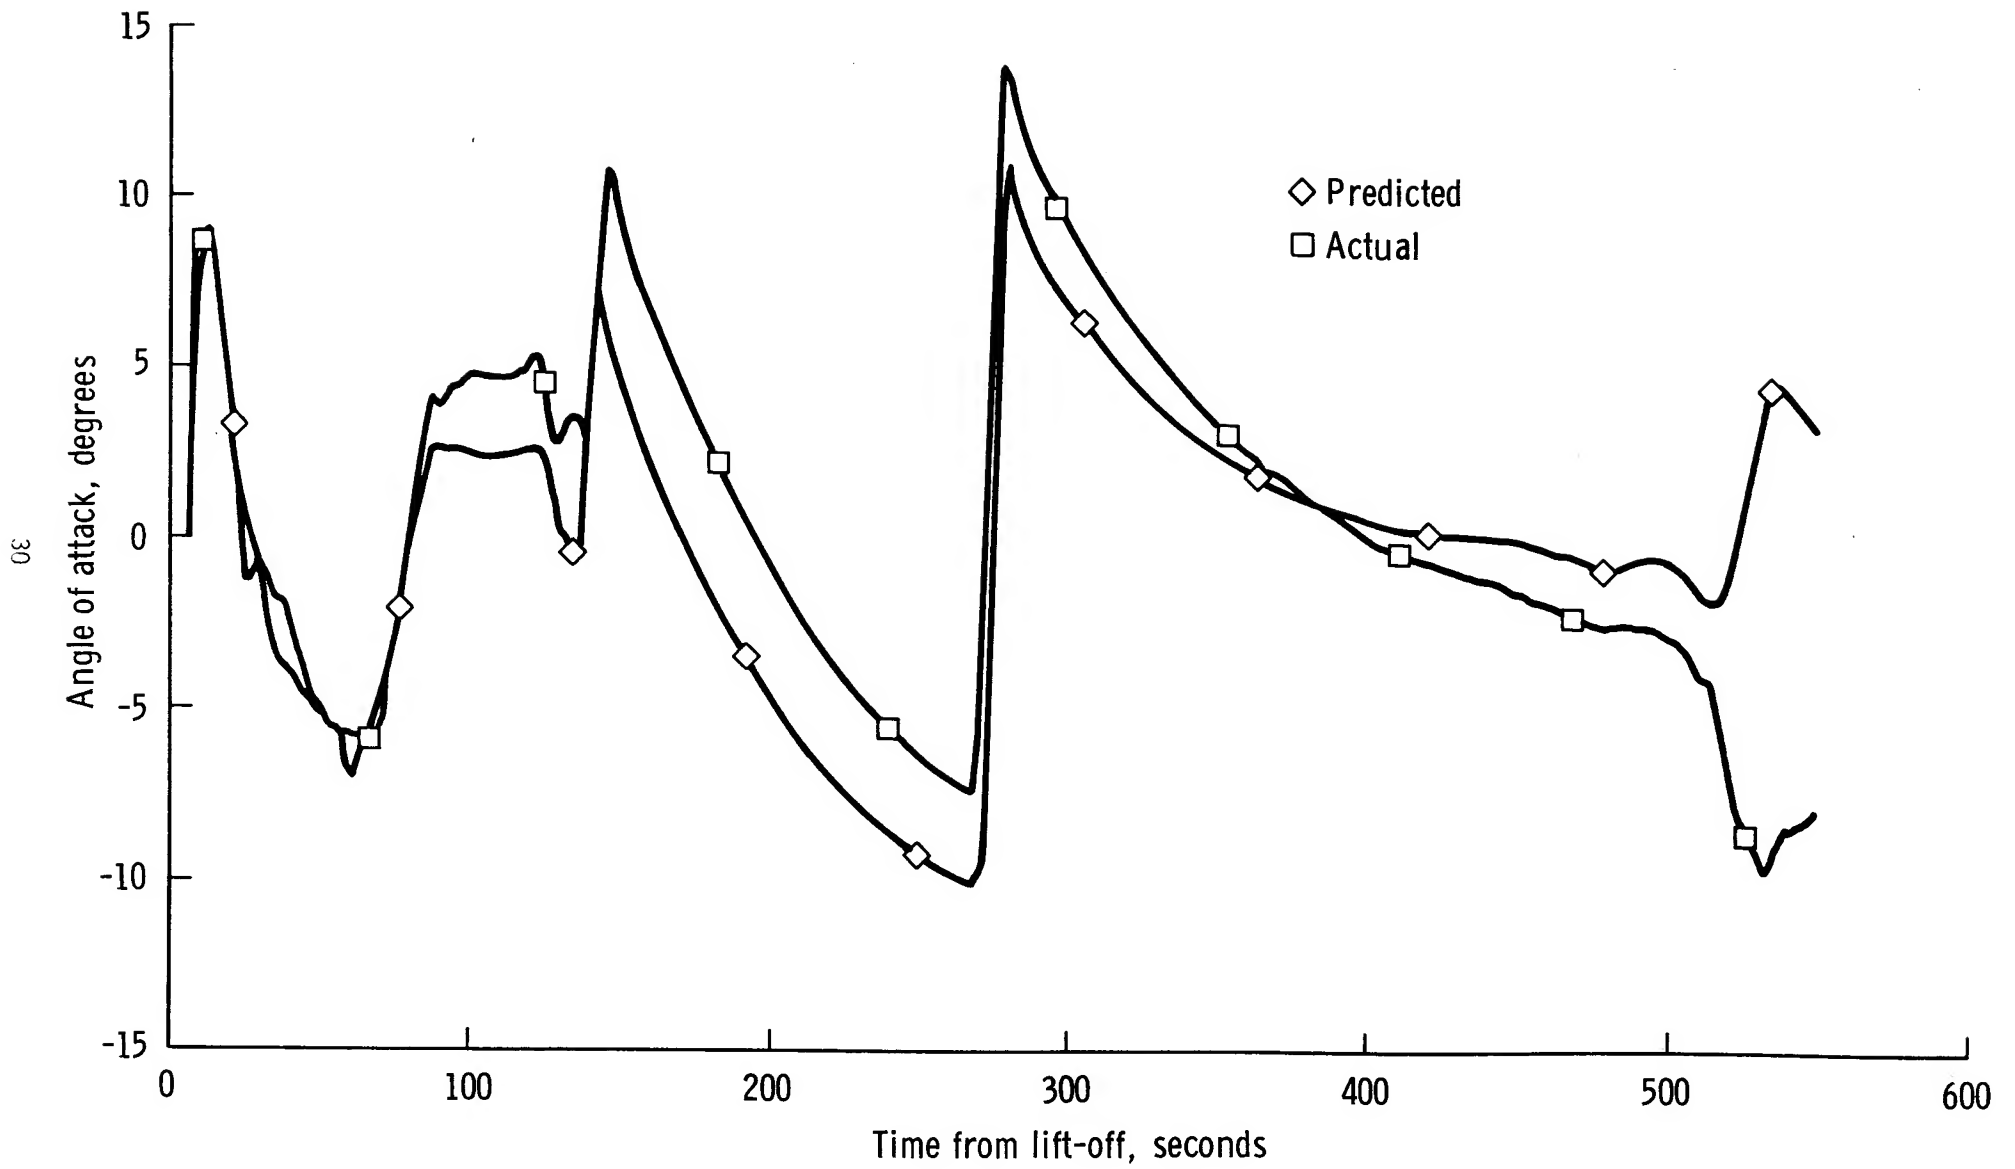
Figure 2-11. - Comparison of predicted and actual angle of attack for STS-1 launch phase.

The flight data show that the ascent guidance, navigation, and control performed in a normal manner. One minor area of concern is the lofting problem (Section 8.0, integrated problem I-1). Another minor area of concern is the fact that the initial attitude error and rate in the pitch axis was not as small at lift-off as expected. The initial attitude error and rate were due to the swaying motion that occurs between main engine ignition and lift-off. A study is in progress to determine if this transient requires any corrective action.

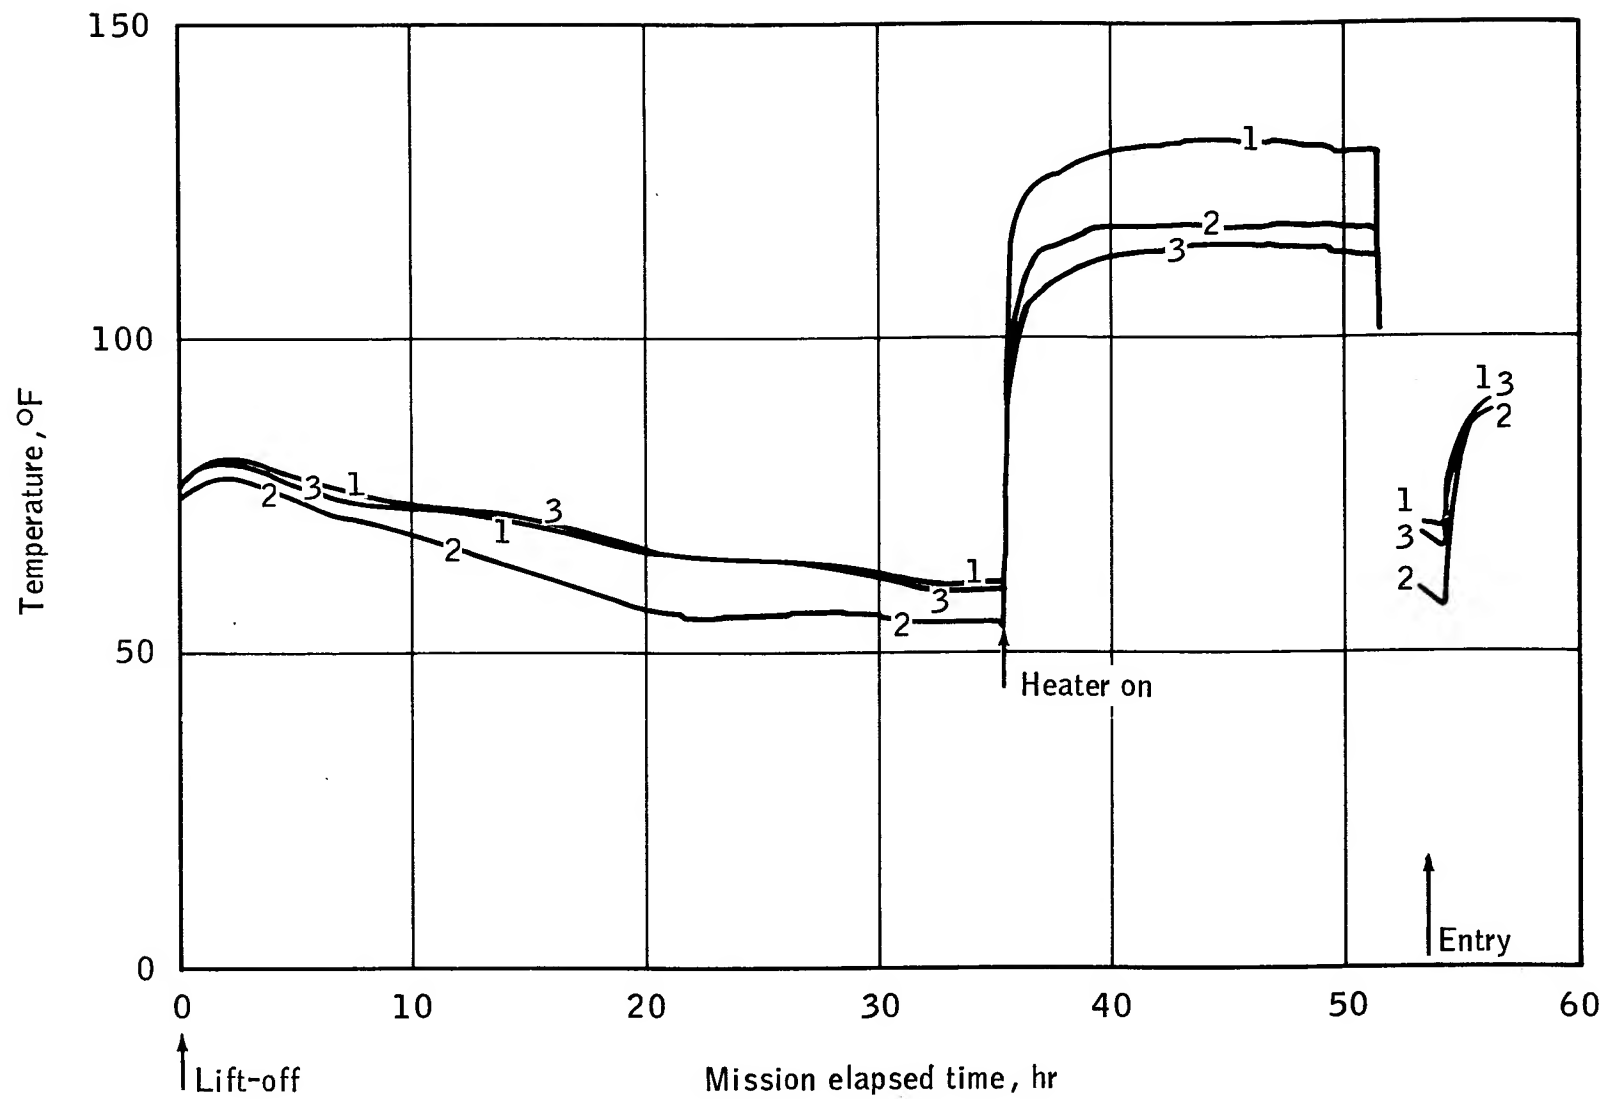
Figure 2-16.- Typical temperature response in RCS forward compartment.

Of particular interest is the performance of the forward RCS compartment heaters. The port heater came on for the first time at 35:20:00 mission elapsed time (MET) as compared with an expected time of 16 hours MET, and this would indicate that the loss from the compartment was much less than expected (see section 8.0, flight test problem report 1e). However, the heater remained on (100-percent duty cycle) until it was disabled, as planned, for entry. A typical temperature response of the port panel heaters is shown in figure 2-16. The expected duty cycle was approximately 25 percent. In addition, the temperatures of the heater panels ranged from 115° to 130° F maximum as compared with an expected range of 132° to 153° F (see section 8.0, flight test problem report 1f). This would indicate either a larger than expected compartment or a heat leak or lower than expected voltage. Evaluation is underway to identify potential causes. No problems are anticipated for STS-2 since the planned major attitude, payload bay to earth, is the same as that of STS-1.

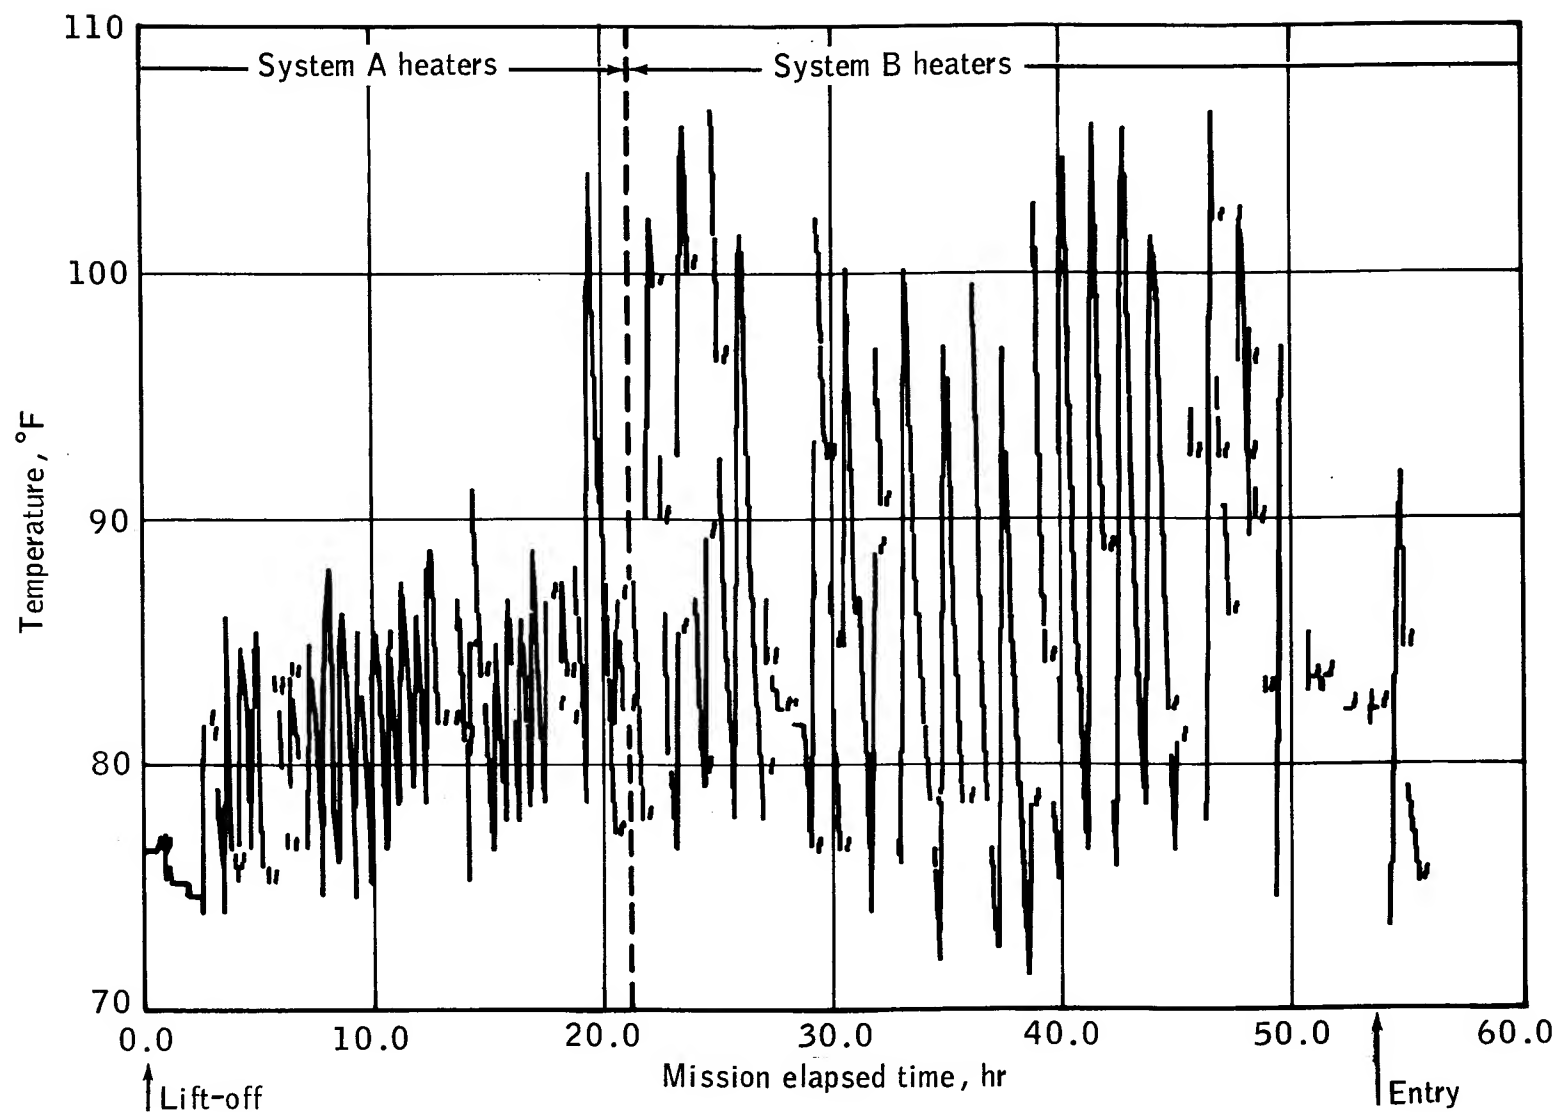
Figure 2-17.- Flash evaporator feed line temperature amplitude change.

At 103:09:30 G.m.t., the FES feed water line heaters on the port side were switched from system A heaters to system B heaters, the switch resulting in a temperature amplitude change (figure 2-17). Mislocation of the temperature transducer is suspected.

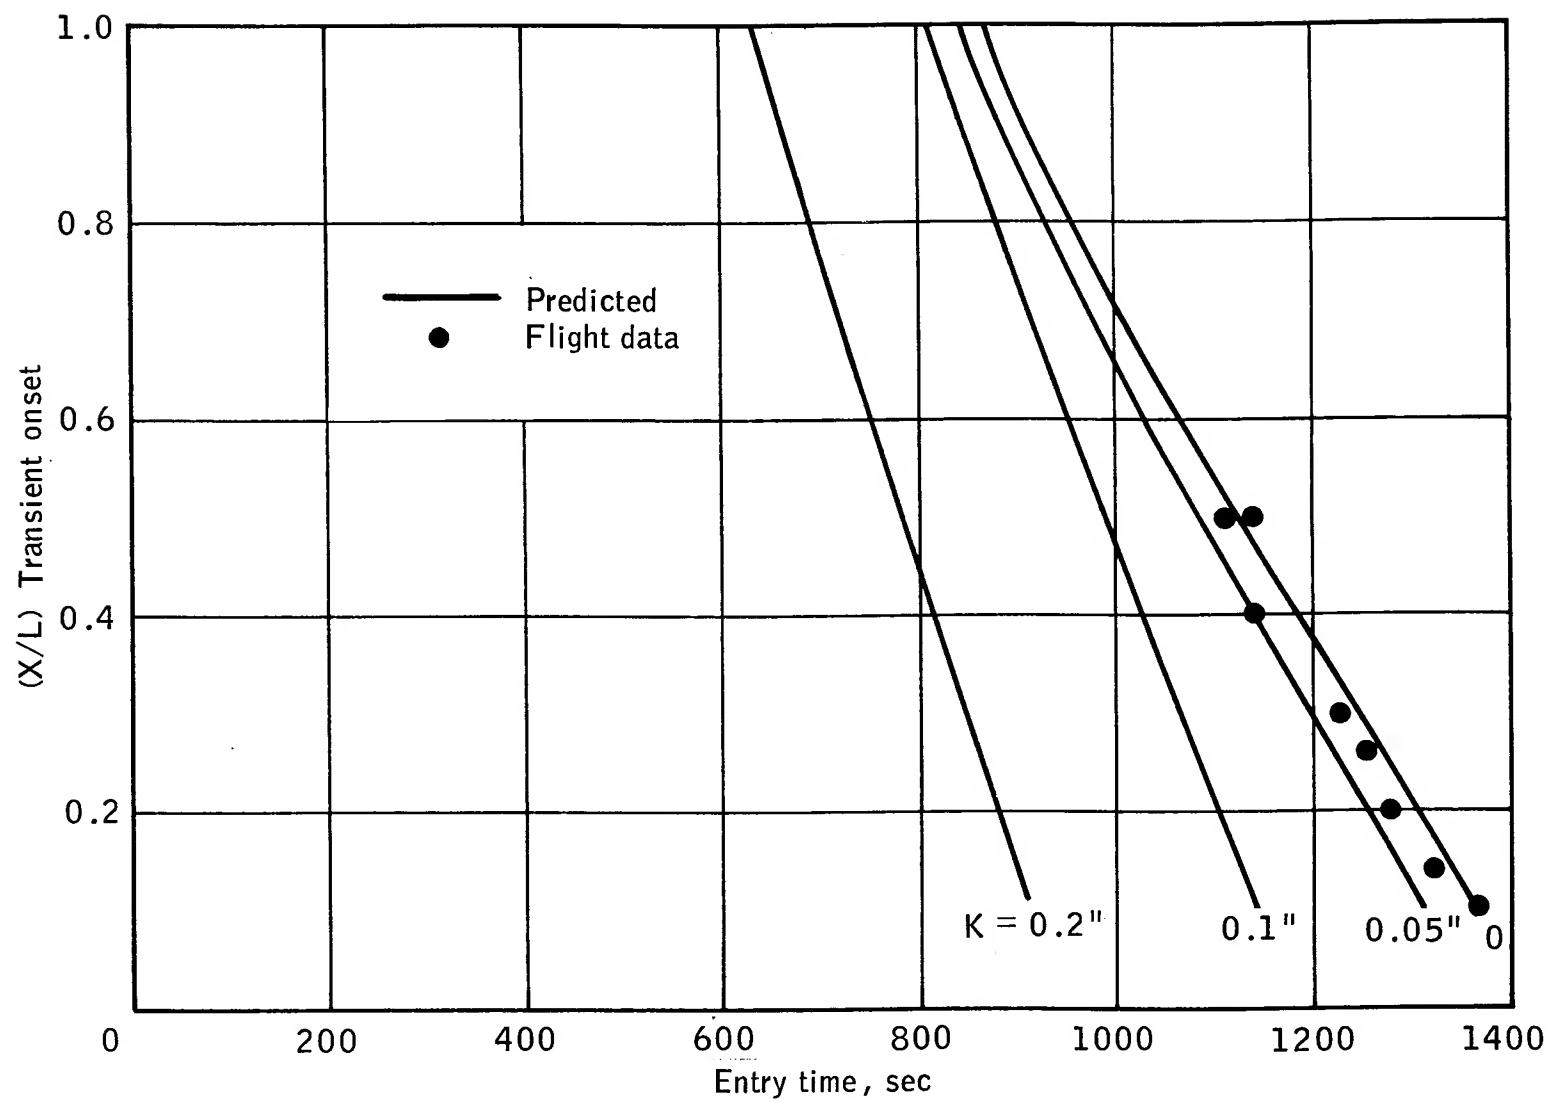
Figure 2-29.- TPS roughness effect on STS-1 boundary layer transition times

criterion predictions (figure 2-29). The higher velocity data are required to evaluate the aft fuselage boundary-layer environment. These data will allow a larger roughness criterion to be imposed on the installation of the Orbiter TPS. The data agreed with the turbulent predictions and with the laminar predictions lowered by 20 percent.

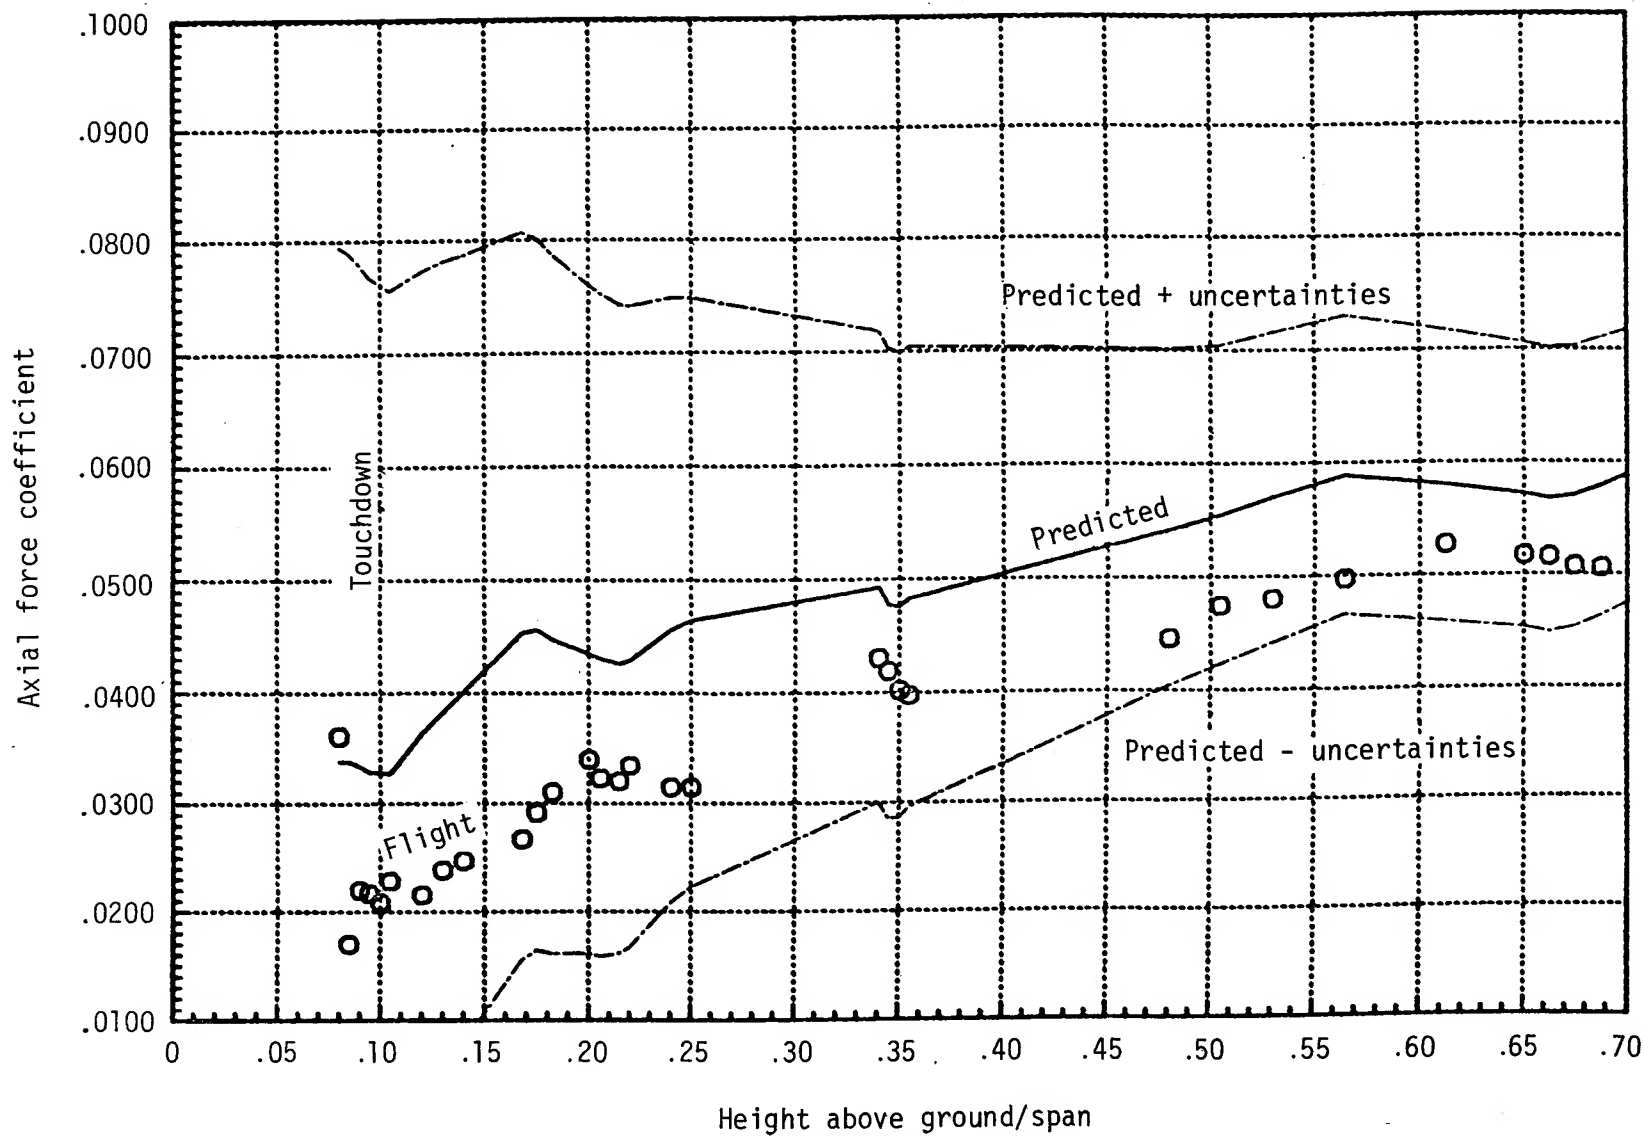
Figure 2-31.- Lower than predicted axial force coefficient during landing.

2.9.2.1 Performance and Trim. - Comparisons of the predicted lift-to-drag (L/D) ratio and the predicted \pm uncertainties data with the calculated STS-1 L/D ratio are shown in figure 2-30. There was no discernable difference between the predicted and actual calculated values down the last 100 ft before touchdown. At that point, ground effects occurred which caused the L/D to be higher than predicted. This difference was traced to the axial force coefficient that was lower than predicted (fig. 2-31).

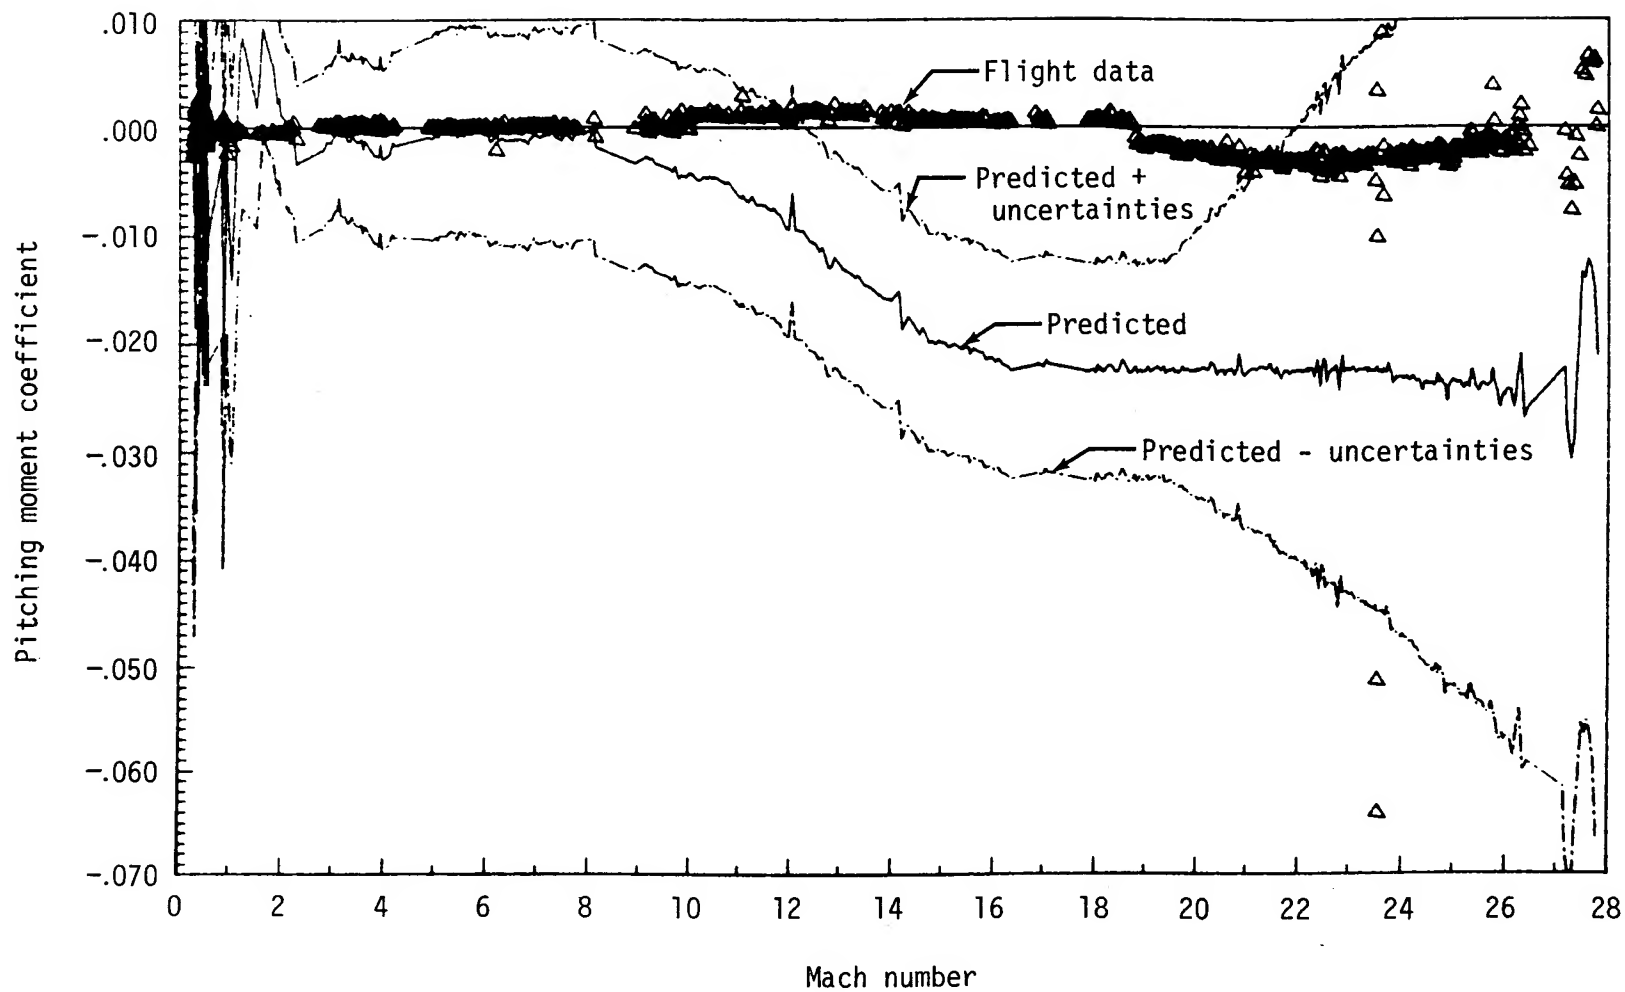
Figure 2-32.- Pitching moment coefficient during entry phase.

The body flap functioned as predicted except at the higher Mach numbers (28 to 8) where the body flap was down 7 degrees further than predicted. Between Mach 21 and 12, the pitching moment coefficient flight values fall outside the predicted and uncertainties band (fig. 2-32) (Section 8.0, flight test problem report 39). Below Mach 8, the pitching moment coefficient followed the predicted value.

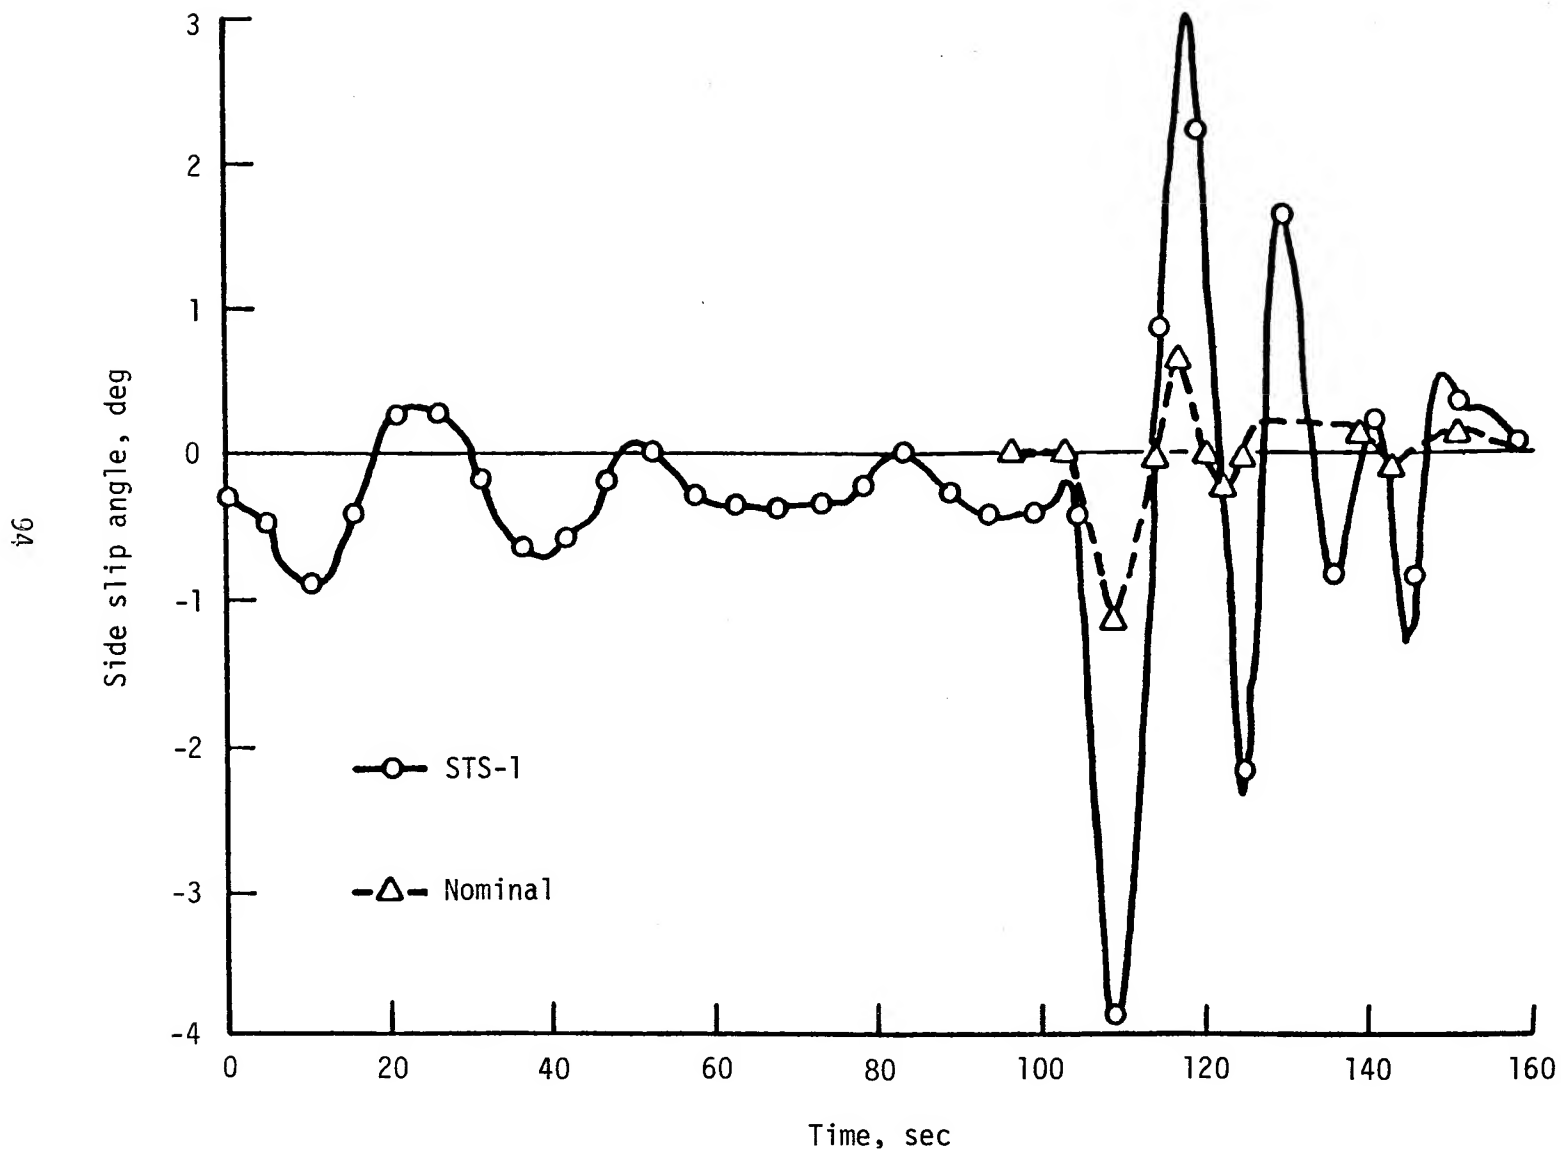
Figure 2-33.- Oscillations from first bank reversal.

2.9.2.2 Bank Reversals. - The initial bank reversal was performed at a dynamic pressure of 14 lb/ft. This reversal created several cycles of lightly damped motion that resulted in peak beta values of 4 degrees (fig. 2-33). Analysis and motion matching studies have shown that this discrepancy resulted from the rolling moment from the yaw thrusters. The predictions had this roll moment included, but at a higher level (fig. 2-34).
